Soil Mechanics Surface Sampler

R. F. SCOTT¹ AND F. I. ROBERSON²

A lunar surface sampler essentially identical to that operated from Surveyor 3 was mounted on Surveyor 7 and performed flawlessly on the moon throughout a range of operating temperatures from $+180^{\circ}\text{F}$ to -167°F . The motor current was sampled during lunar bearing and trenching tests, and these data, together with preflight calibrations enabled us to calculate the forces involved in these tests. After minimal lunar surface testing, the surface sampler was employed to release the sensor head of the α -scattering instrument, which had jammed in its background position. Subsequently, the sensor head was relocated to analyze a rock and, still later, to analyze some subsurface lunar material. The mechanical tests of the surface in the vicinity of Tycho indicated that the surface behaved in a manner that was quantitatively similar to the behavior of the material close to Surveyor 3, but the surface near Tycho appeared qualitatively to be more deformable and less brittle. A rock was weighed and found to have a density between 2.4 and 3.1 g/cm³ (earth basis). Another rock was broken by a moderately hard blow fro

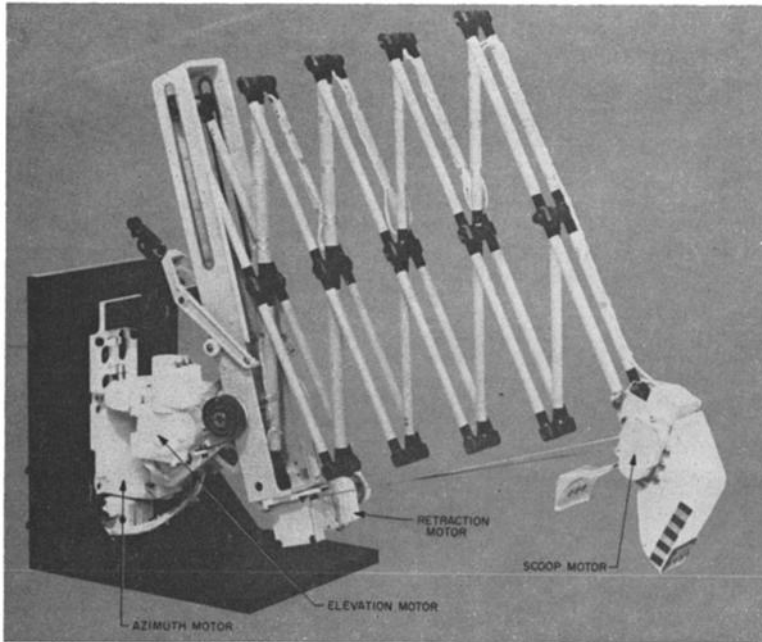
Fig. 1. Surface sampler on test stand, partially extended.

Scoop. The surface-sampler scoop is attached to the end of the extension/retraction mechanism (Figure 1). On Surveyor 7, the flat foot of the scoop door incorporated two embedded rectangular horseshoe magnets. In Figure 2 these magnets are shown outlined by fine-grained material after they made contact with the lunar surface.

unit, the elevation and retraction motors have a sensor attached to each motor housing (Figure 1).

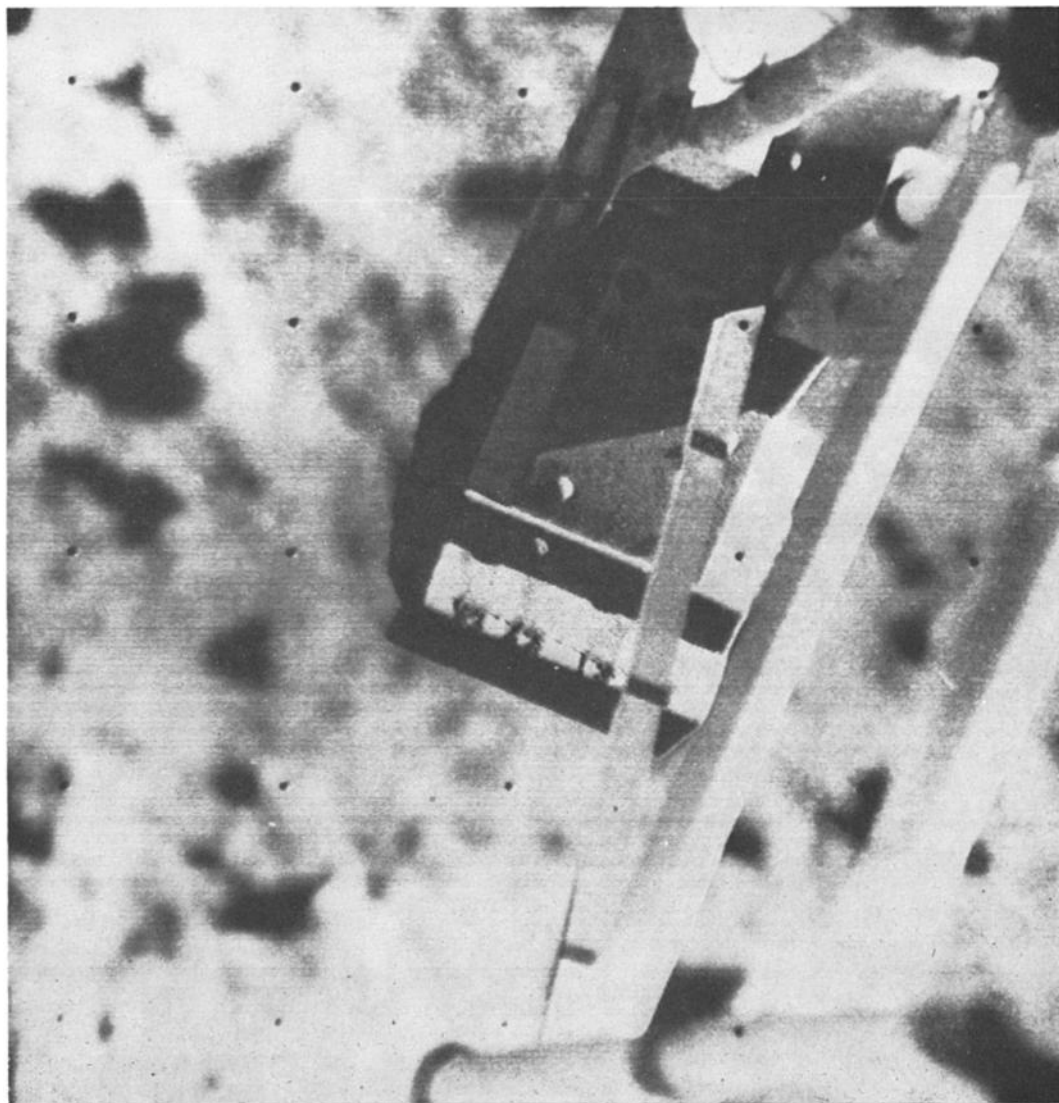
Fig. 2. Surface-sampler scoop holding rock A. Note that the rock is slightly larger than the width of the scoop.

followed bearing test 5. The rock was lifted and motor-current data taken to give weight information. The rock was dropped after this first pickup, and it landed at position A' shown in Figure 16. Figure 2 shows the rock in the scoop before it was dropped.

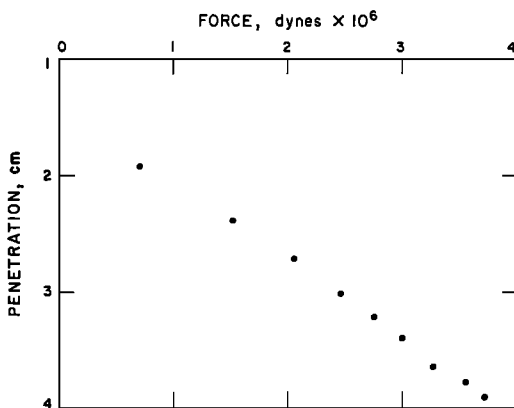
Fig. 4. Force versus penetration curve for bearing test 2.

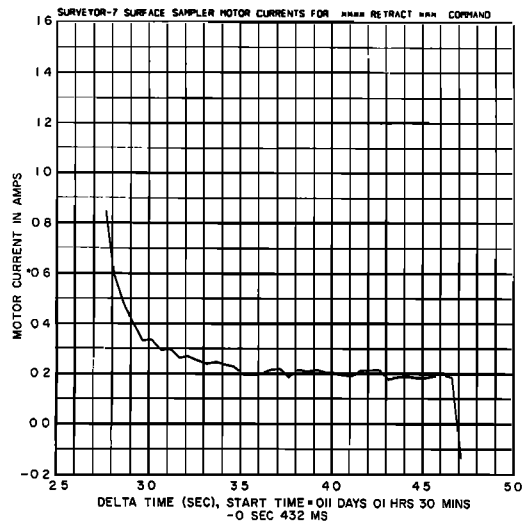
Fig. 5. Typical computer output plot of post-mission processed surface-sampler motor current.

average of the motor current in which the first four samples in a given burst are ignored. These first four samples indicate a motor starting transient.

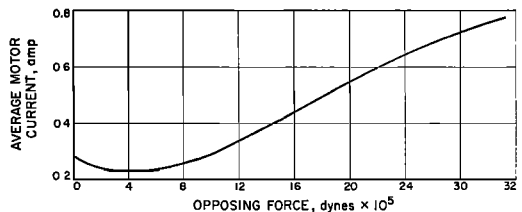
Fig. 6. Calibration curve produced from pre-flight calibration performed at Cape Kennedy, Florida. This curve shows force versus current for the bearing test mode with the surface sampler at 147-cm extension.

Calibration. Shortly before launch, the surface-sampler subsystem calibration was performed at Cape Kennedy, Florida. At a normal voltage of 22 volts the motor current required to drive the surface sampler against a series of forces was recorded for this calibration. The opposing force was varied in controlled steps

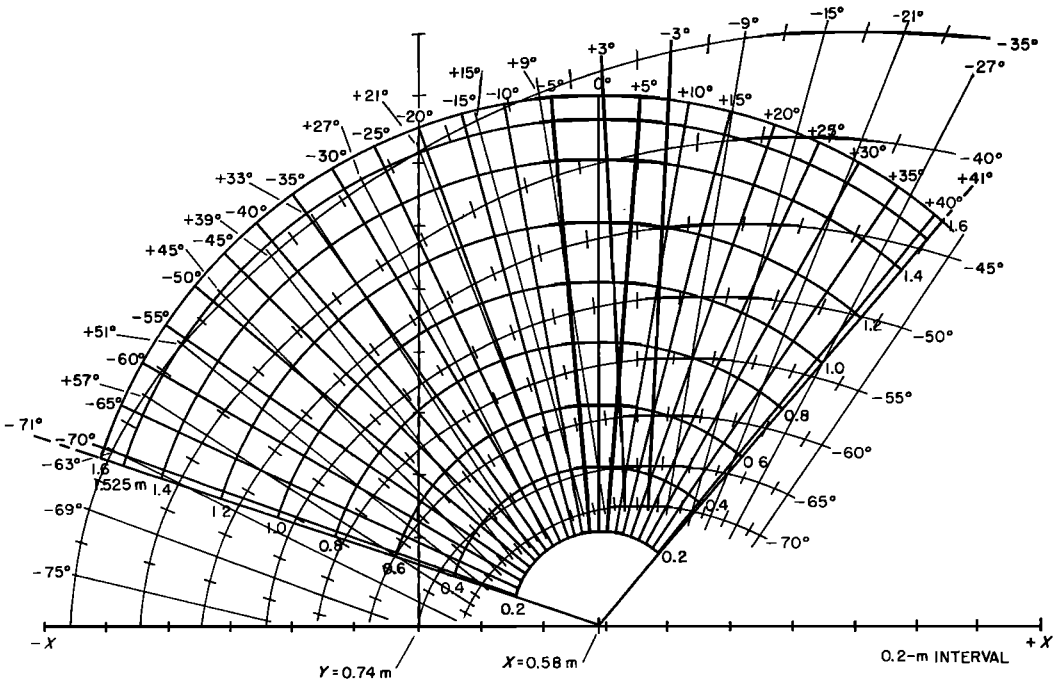
Fig. 7. Operational aid used for selecting television camera position to view specific areas of surface-sampler operations.

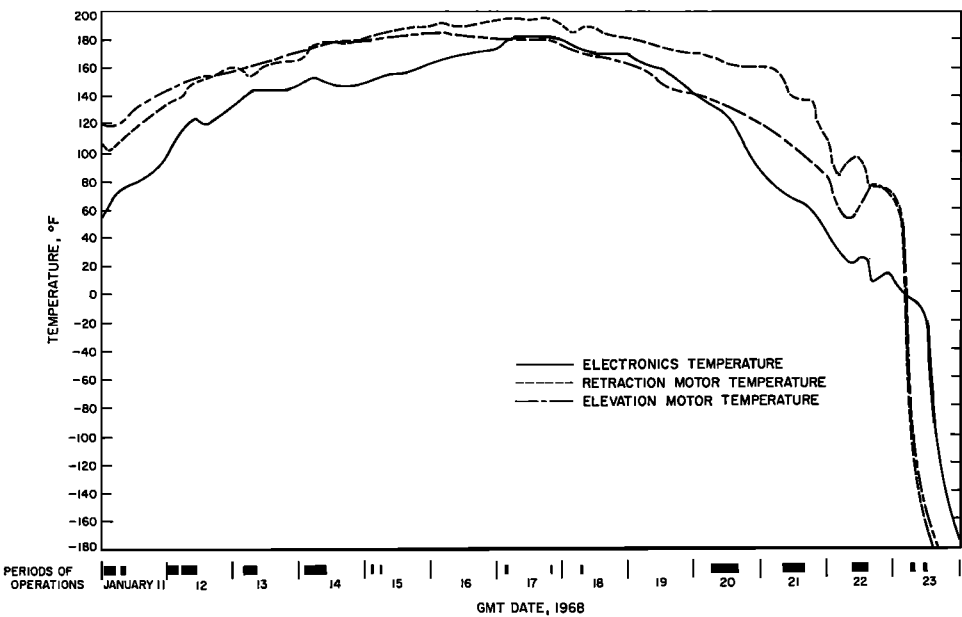
Fig. 8. First lunar day surface-sampler temperatures. Periods of operation are noted by the bars at the bottom of the figure.

face-sampler subsystem was flawless under a wide range of operating conditions. Figure 8 shows the temperatures of the elevation and retraction motors and of the auxiliary electronics unit throughout the first lunar day. During the critical period around lunar noon (days 015 through 018), the surface sampler was operated to provide shade for the thermal-control surfaces of the α -scattering instrument's sensor head. Without this shade, it is possible that the temperature of the sensor head would have exceeded its survival limits.

Several of the shading operations were performed when the auxiliary electronics unit of the surface sampler was above its upper operating limit. In these operations, the motors operated normally at temperatures up to 180°F.

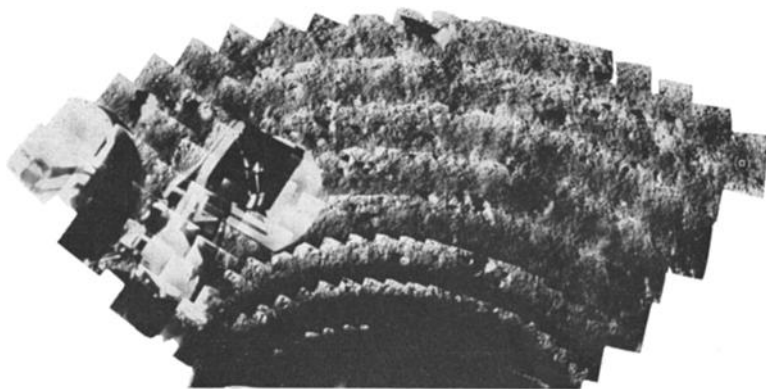
Fig. 9. Mosaic of Surveyor 7 pictures showing the surface-sampler area of operations before activities began.

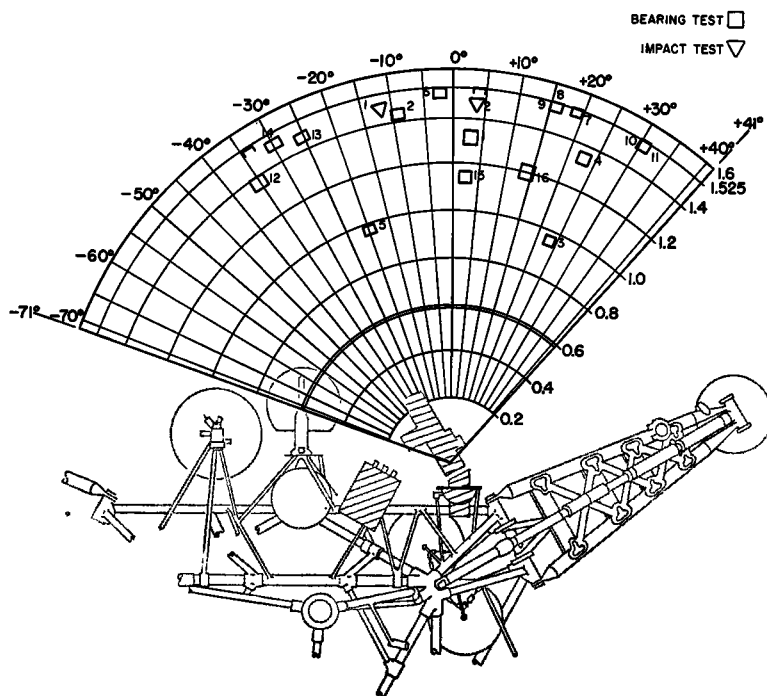
Fig. 10. Plan view of surface-sampler operations showing location of bearing and impact tests performed.

Bearing test 5 was performed by moving left and locating at the position noted in Figure 10. This bearing test was performed by using a single 2.0-second lower command and by attempting to contact the surface during the steady-state part of the travel. This contact was achieved, and the result is shown in Figure 12c.

After completing trench 2, the scoop was extended and moved right to the point noted as bearing point 7 in Figure 10. With the scoop still open, a bearing test was performed by use of command tape 907. A series of seven 0.5-

ployed position at the left-hand side of the picture; the surface sampler is in the process of excavating subsurface soil to provide the third sample for analysis. Some of the surface-sampler tests, identified in Figures 10 and 16, may also be seen in Figure 23. In particular, just to the right of the position of the surface sampler, a fairly large rock (rock B) is seen at the outer edge of the surface-sampler area. On the near side of the rock, two small trenches demonstrate that the rock was just outside the surface sampler's reach. To the right of the rock is a long, 15- to 18-cm-deep trench, identified as trench 2 in Figure 10.

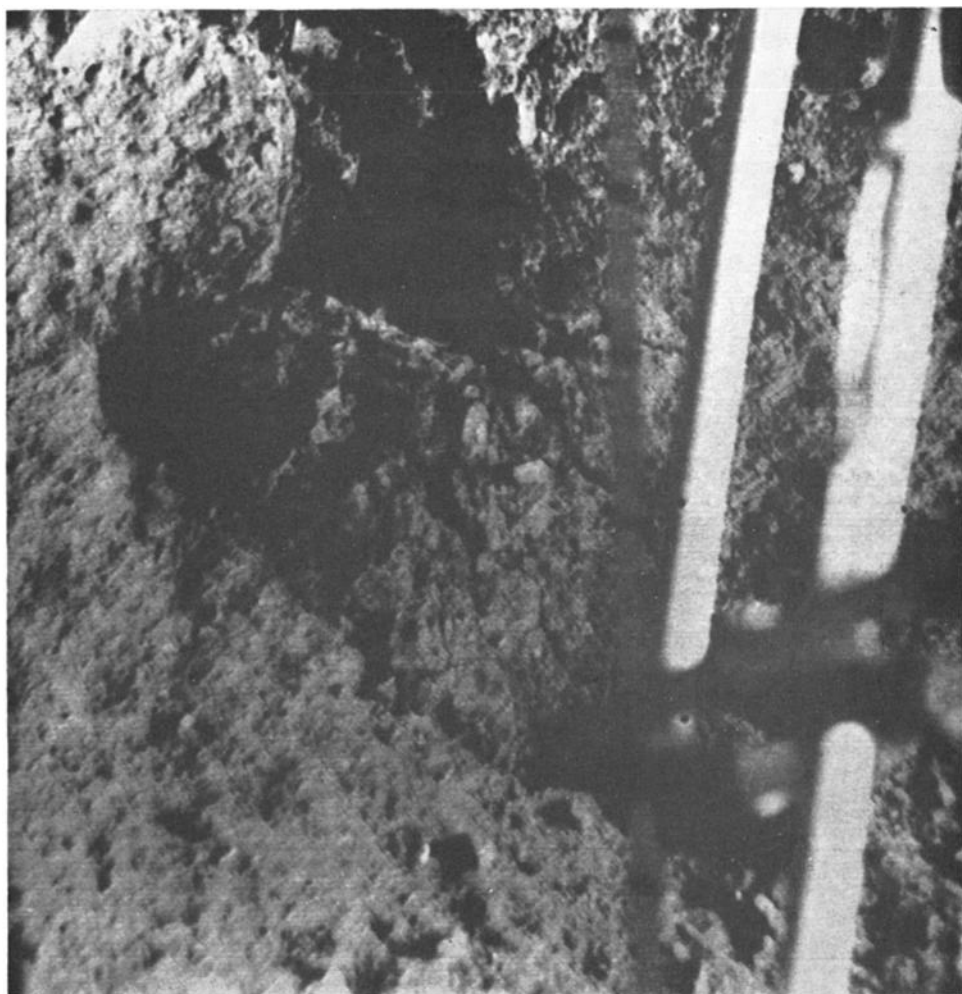
Fig. 11. Bearing test 1. This picture shows the first surface-sampler contact with the lunar surface at the Surveyor 7 landing site.

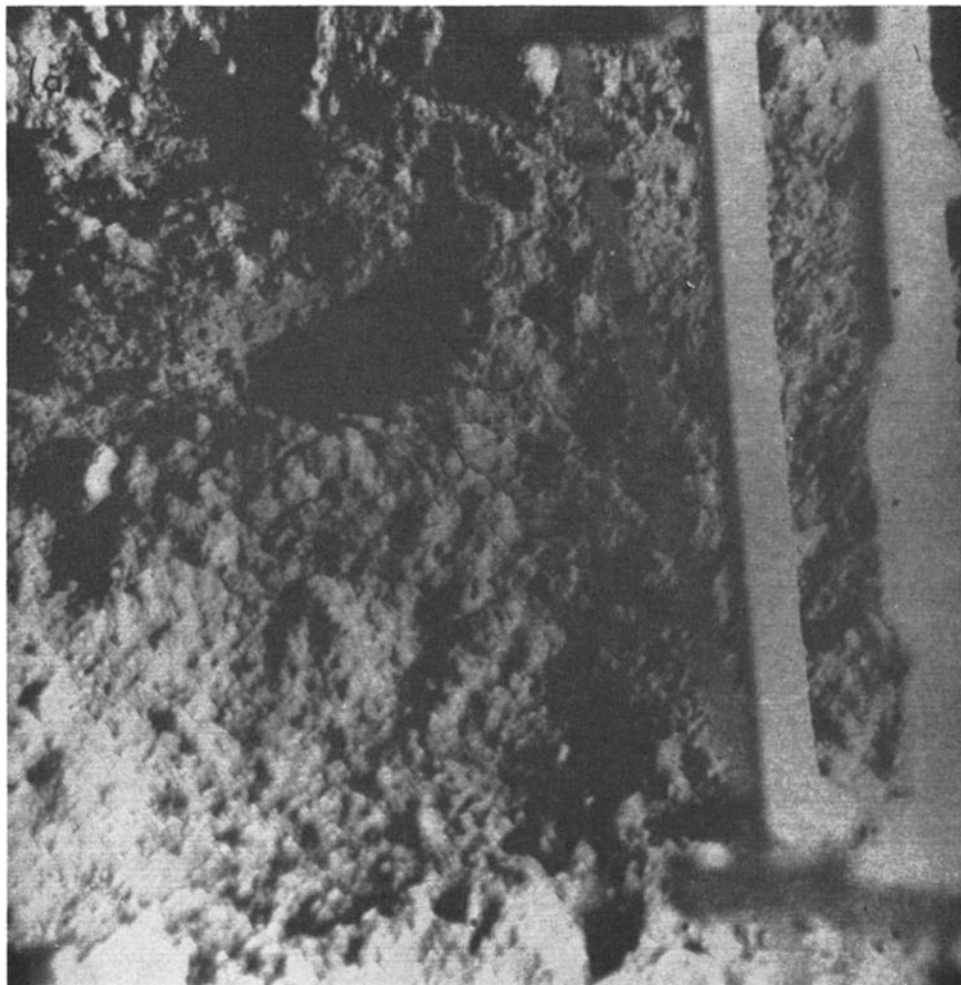
Fig. 12a. Results of surface-sampler bearing test 2.

Since bearing test 1 and the previous calibration tests of the surface sampler on the moon indicated that the sampler was in good operational condition and, in particular, that the motor currents appeared reliable, it was decided to perform a second bearing test to the left of bearing test 1 and at greater extension, using command tape 907. Bearing test 2 was consequently performed; the appearance of this test is somewhat different from that of bearing test 1, although some bulging of the surface material

It is felt that the difference between bearing tests 1 and 2 probably results from the different angle of penetration of the surface-sampler scoop into the lunar soil; in bearing test 1 the position of the scoop tended to drag the surface material toward the spacecraft. In addition, bearing test 2 appeared to have been performed on a level surface. Once again, in Figure 12a, it can be seen that the disturbed material cracks to some extent and exhibits displacement to some distance from the point of application of the force.

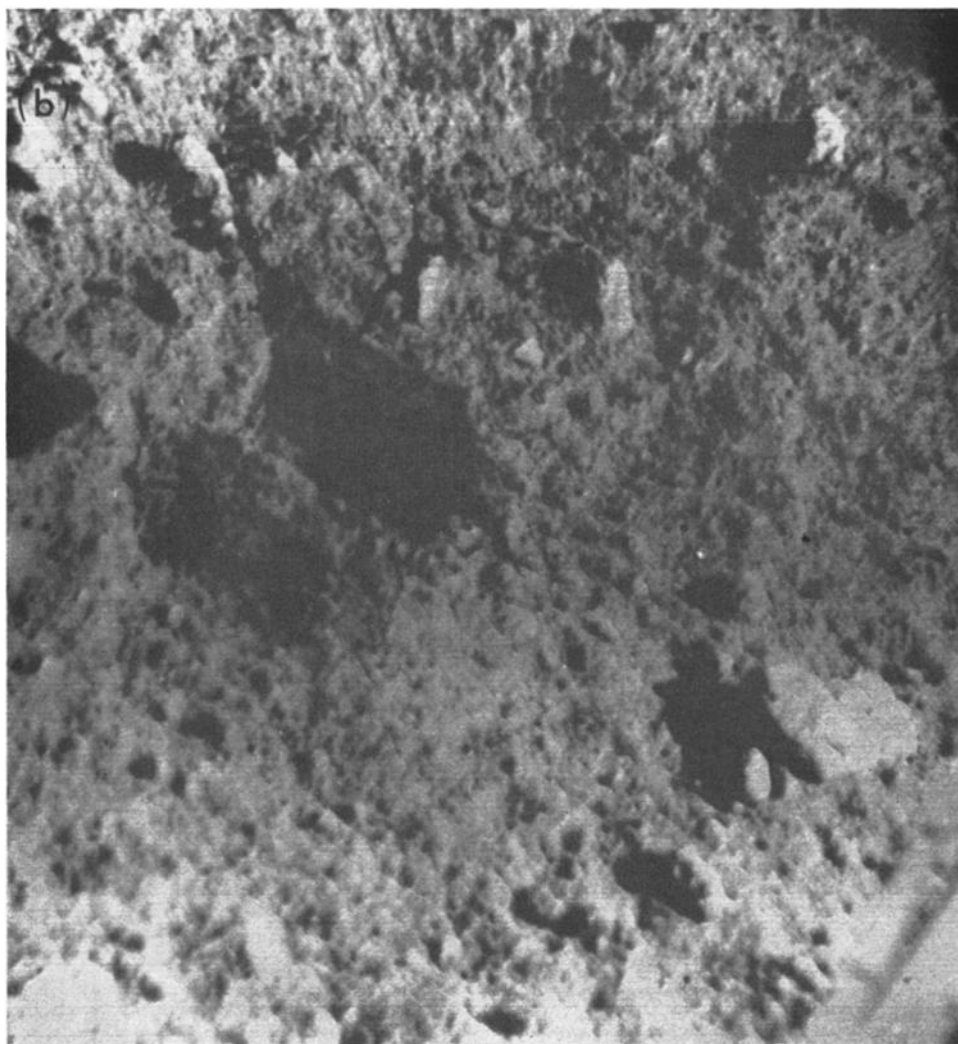
Fig. 12b. Results of surface-sampler bearing test 4.

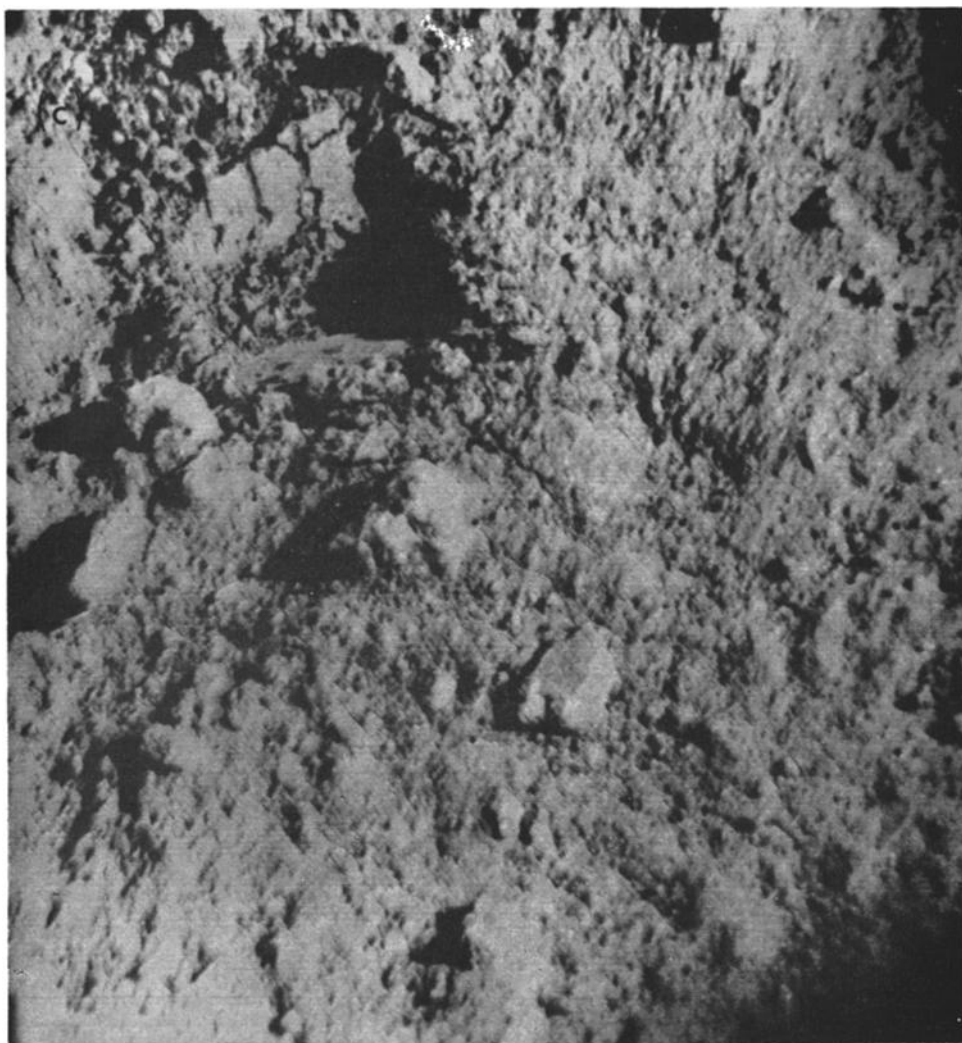
Fig. 12c. Results of surface-sampler bearing test 5.

was attained, and the soil was disturbed to a distance of approximately 8 cm from the near edge of the surface sampler. In this test, a piece of rock (or a rock fragment) seems to have been encountered near the surface at the left-hand top corner of the surface-sampler impression (Figure 12b), since there is some soil cracking, and the surface appears somewhat bulged beyond the surface-sampler impression. It appears that the surface sampler may have pressed down on one corner of the rock fragment that was slightly below the surface, and that this fragment tilted upward, thereby cracking the surface.

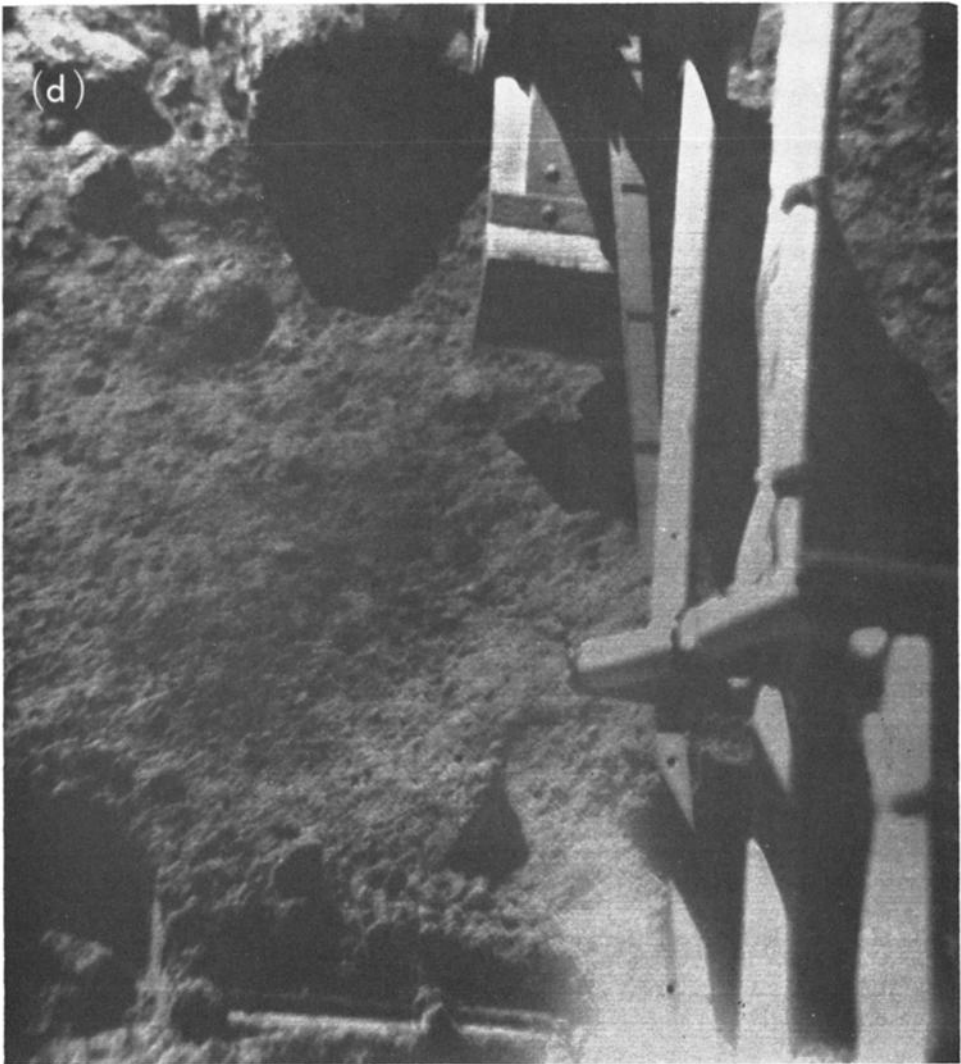
Fig. 12d. Surface-sampler bearing test 6 in progress.

The initial pickup of rock A (Figure 12d)

From this position, the surface sampler was extended to its maximum distance; the scoop opened, and a 2.0-second-command bearing test was performed at bearing point 6 (Figure 10). After the scoop was driven into the surface in this bearing test, a series of nine 2.0-second retract commands completed the first pass through trench 2 (Figure 16). At the end of operations

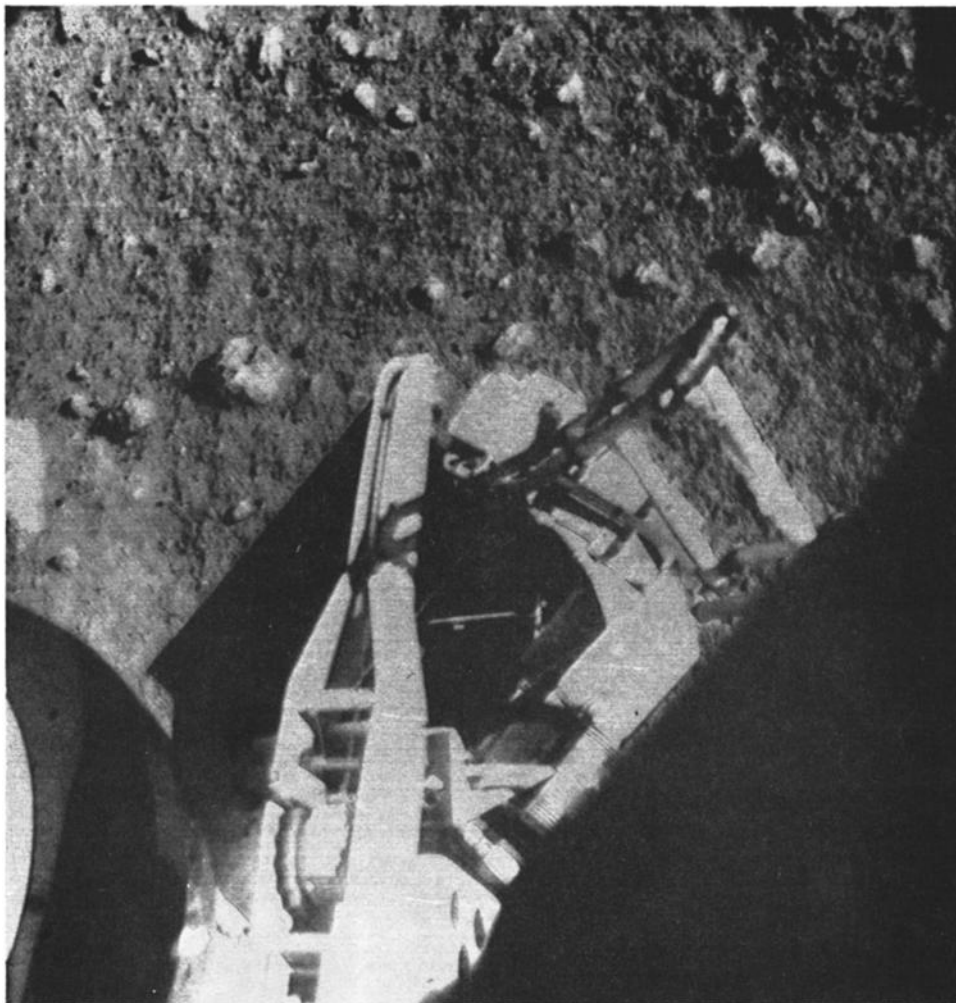
Fig. 13. The surface sampler is shown forcing the sensor head against the helium tank, preparatory to applying a downward force to free the sensor head.

ure 13) it appeared that the α -scattering instrument was wedged between the helium tank, the surface-sampler scoop, and some part of the α -scattering instrument's standard-sample bracket. Under this condition, surface-sampler lower commands applied a downward force to the α -scattering instrument, which came free and moved down several centimeters. This allowed the scoop to be placed on top of the α -scattering instrument and a direct downward force to be applied to it. The thermal mirror on the sensor head was an aid in positioning the scoop and, as can be seen in Figure 14, afforded a view of the scoop interior. The α -scattering instrument was lowered to a point at which it

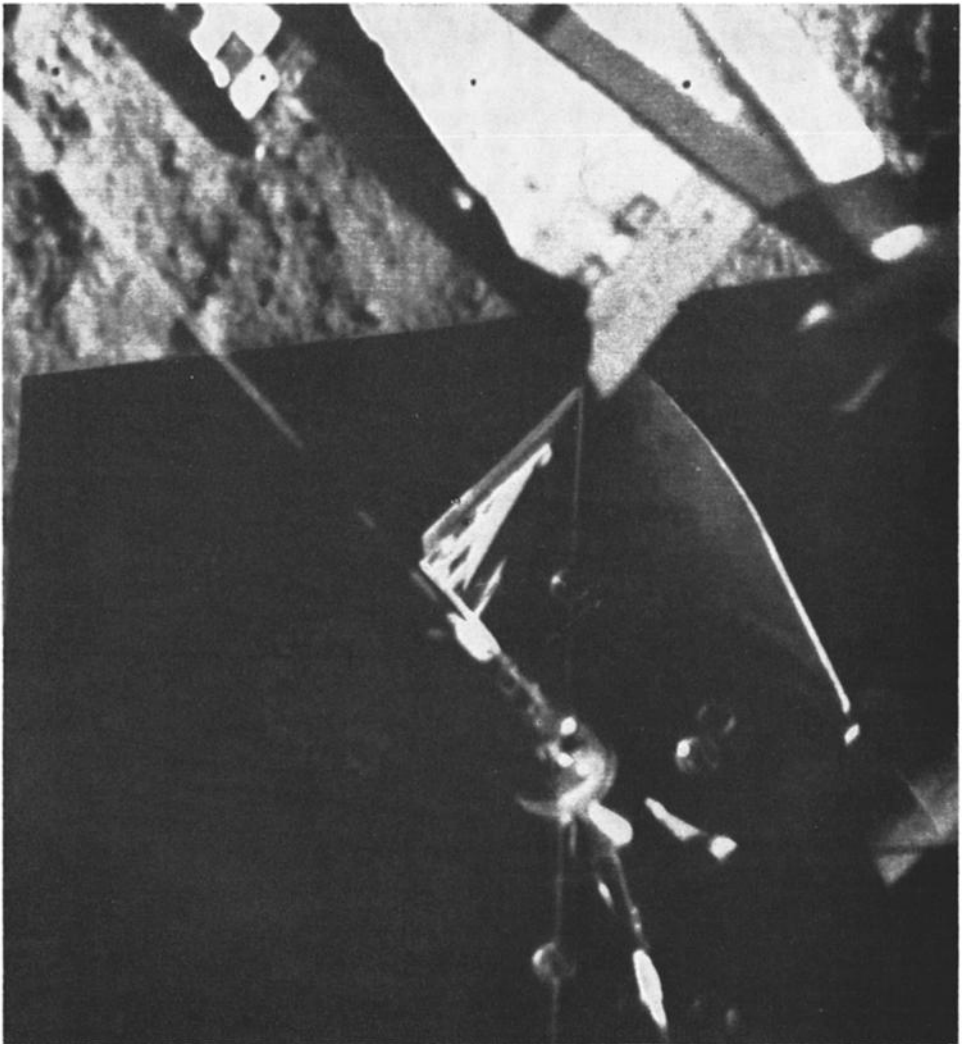
Fig. 14. The thermal radiating mirror of the sensor head affords an excellent view of the surface-sampler scoop interior when the scoop is positioned above it.

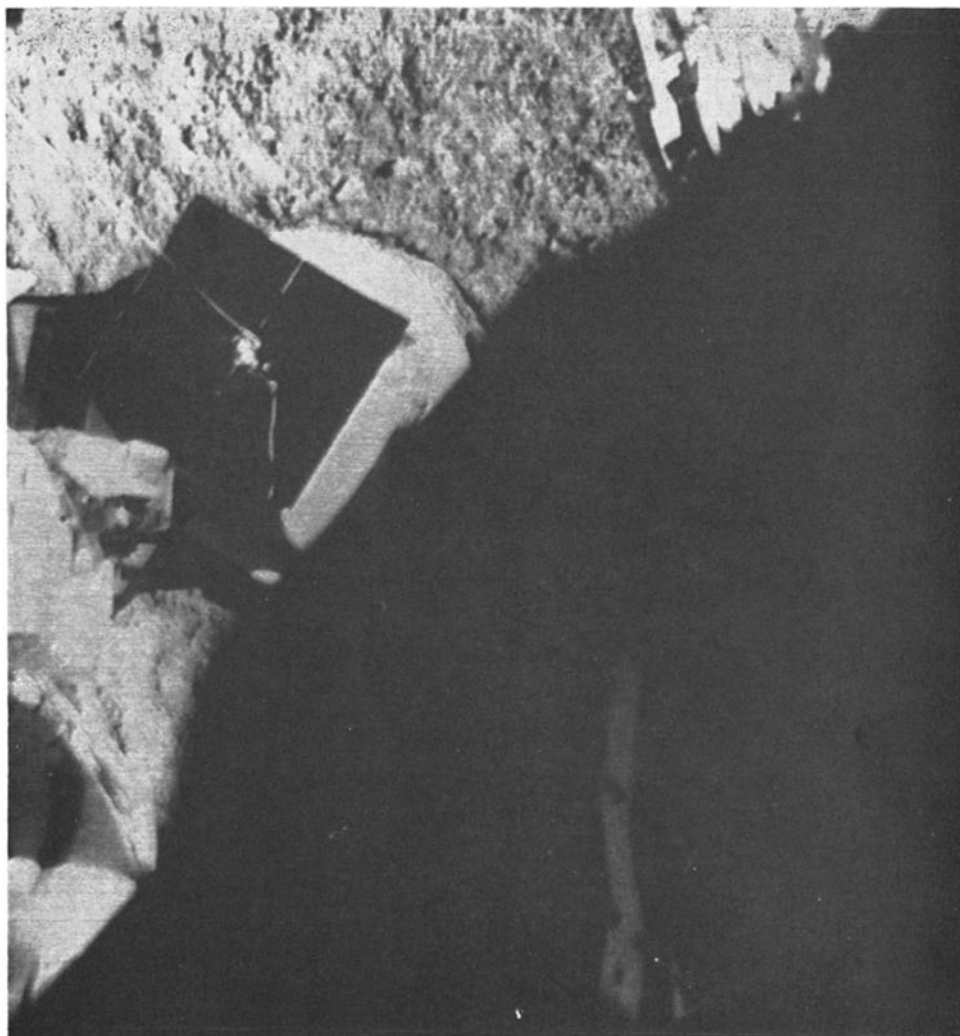
Fig. 15. The sensor head is shown on the lunar surface in position for its first analysis after the surface sampler has forced it down.

appeared to be on the surface, but a short test of the instrument counting rate showed that it was not. The surface sampler was again positioned above the sensor head and continued to force it down until it was on the surface in the position shown in Figure 15.

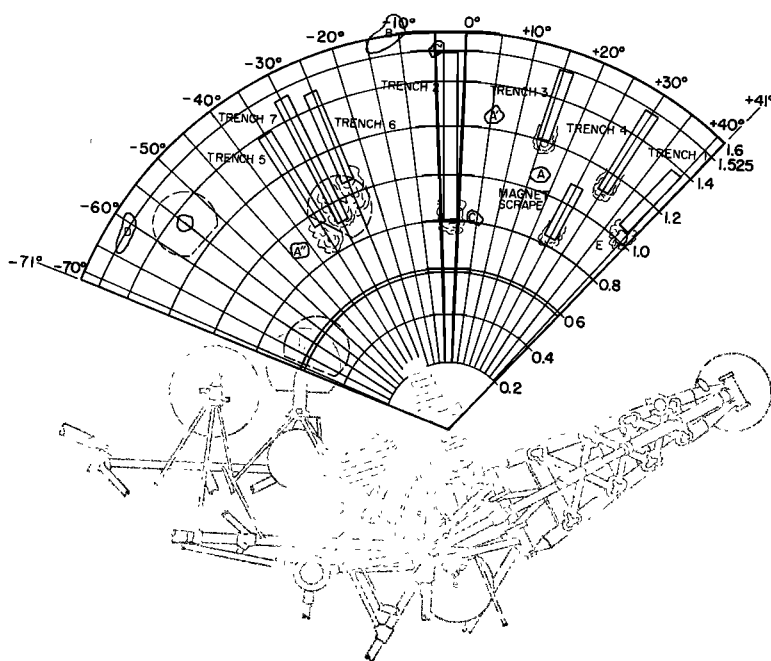
Fig. 16. Plan view of surface-sampler operations showing trenches, rocks, and the α -scattering instrument.

Trench 4 was dug by retracting three 2.0 second steps from bearing point 11. The area noted in Figure 16 as the magnet scrape trench was the location of operations following trench 4. The scoop was lowered to the surface with the door closed and, by a series of 2.0-second retract commands, was dragged across the surface in a trenching mode. After three such commands, the scoop was lifted clear of the surface

Day 021. Operations for day 021 started with the performance of 2.0-second elevate commands at the final position of rock A, noted as position A" in Figure 16. These commands were executed to gather no-load motor-current data before later lift tests with the sensor head at the same position.

After positioning the sensor head on its third sample, impact tests 1 and 2 were performed. These tests consisted of positioning the scoop above the points noted in Figure 16, elevating to the desired height, and releasing the elevation drive clutch. Following the impact tests, bearing test 15 was performed, by using command tape 907. Figures 10 and 16 show that bearing point 15 is very near trench 2. This test was performed by taking pictures of the trench wall between each of the bearing commands in order to observe the behavior of the wall.

Trenching operations. Trenching operations during the Surveyor 7 mission were made for a variety of purposes. The first trench (Figure 16) was dug at the extreme right-hand end of the surface-sampler operations area. This area was selected because it was possible to bring the surface sampler to the extreme right-hand stop very readily after moving it away from the

Following deployment of the sensor head of the α -scattering-instrument, another trench was attempted in approximately the middle of the surface-sampler operations area (see Figure 16).

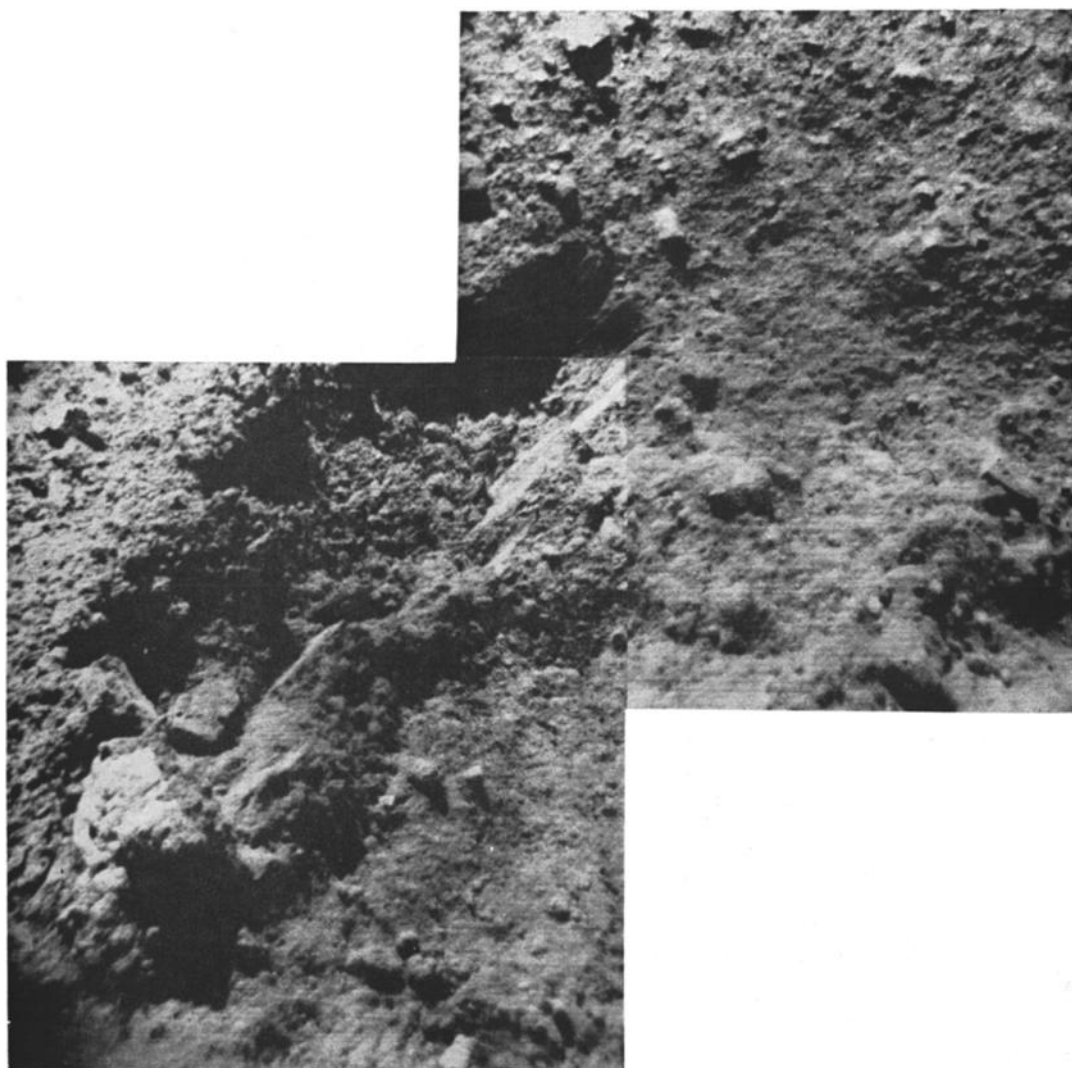
Fig. 17. Mosaic of trench 1. Note the irregular shape and shallow depth of the trench.

1 (Figures 16 and 17). After two 2.0-second elevate commands, the clutch was released, and the scoop blade struck the rock. As discussed below, the rock fractured under this blow.

Some shorter trenches are visible on the right-hand side of Figure 23; on the extreme right-hand edge lies a shallow trench, which was the first trench attempted. This trench could be excavated to a depth of only 2.5 to 5 cm because of the presence of rock immediately below the surface. At the foot of this trench is a small rock fragment (rock E), which was broken by the surface sampler into two fragments after the picture was taken. On the left-hand side of the figure, just to the right of the shadow cast by the sensor head is a somewhat rounded rock (rock A), which was weighed. Many surface-sampler operations involved this rock, which

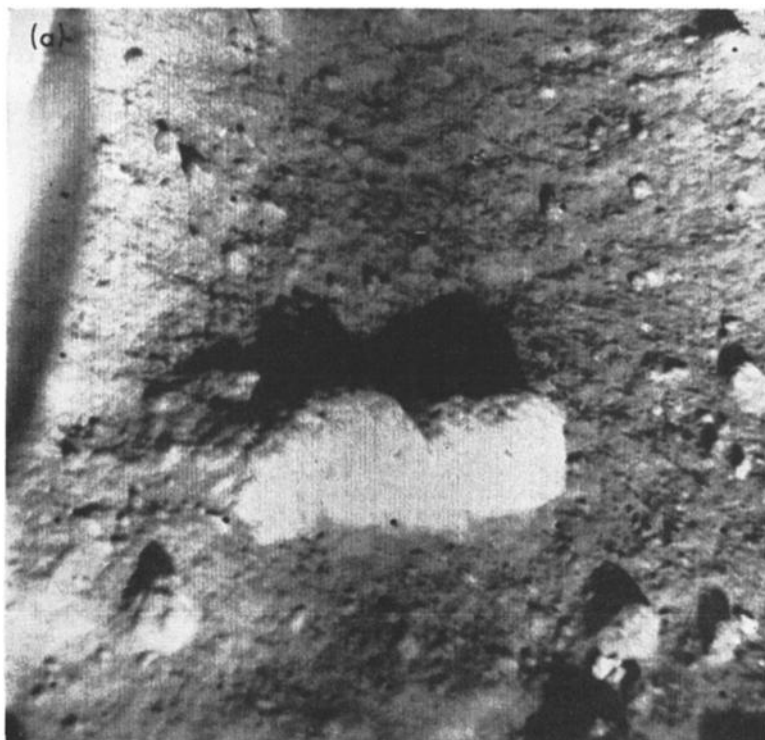
Fig. 18a. Undisturbed view, showing exposed smooth face of rock D.

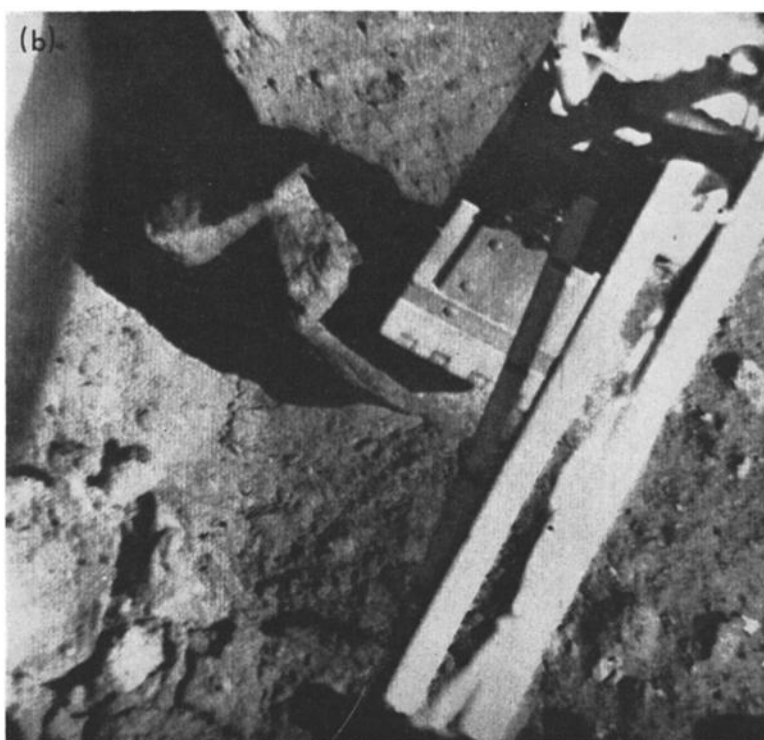
Fig. 18b. View of rock D after moving, showing angular, fragmented underside.

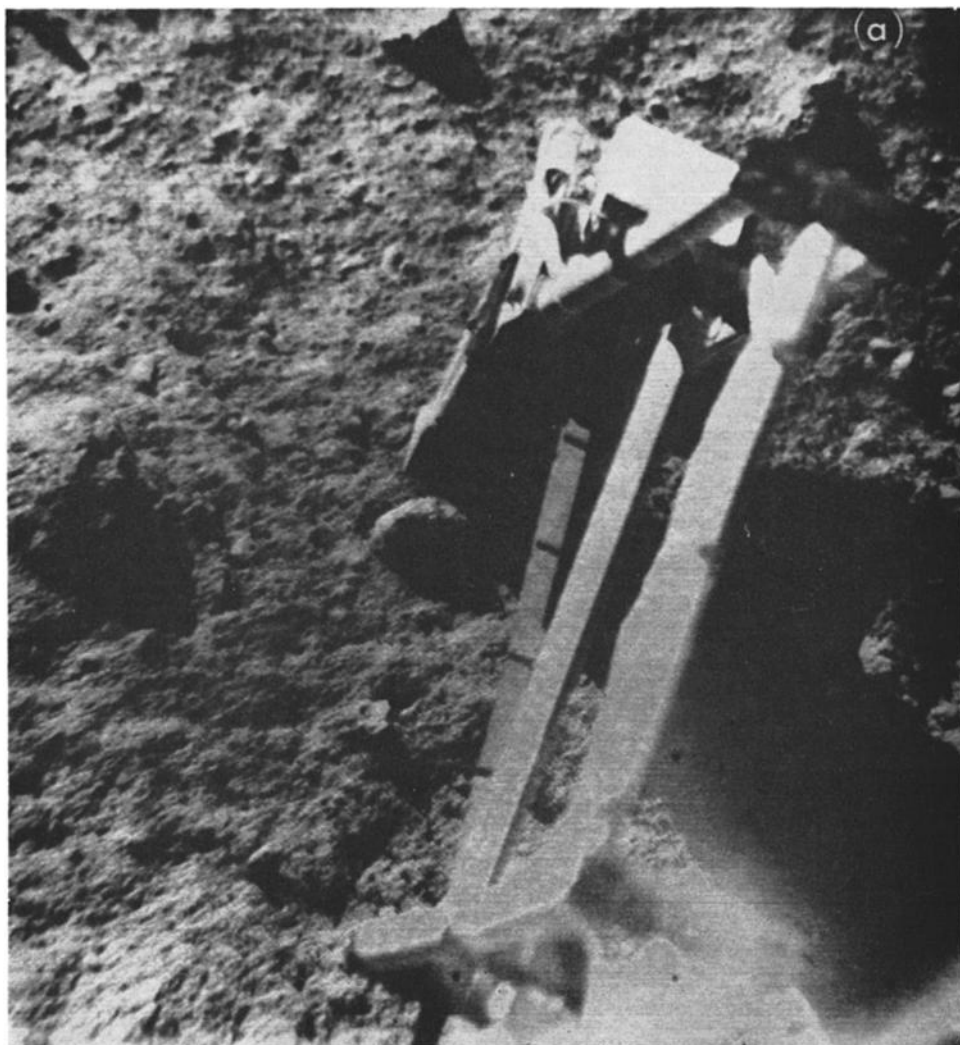
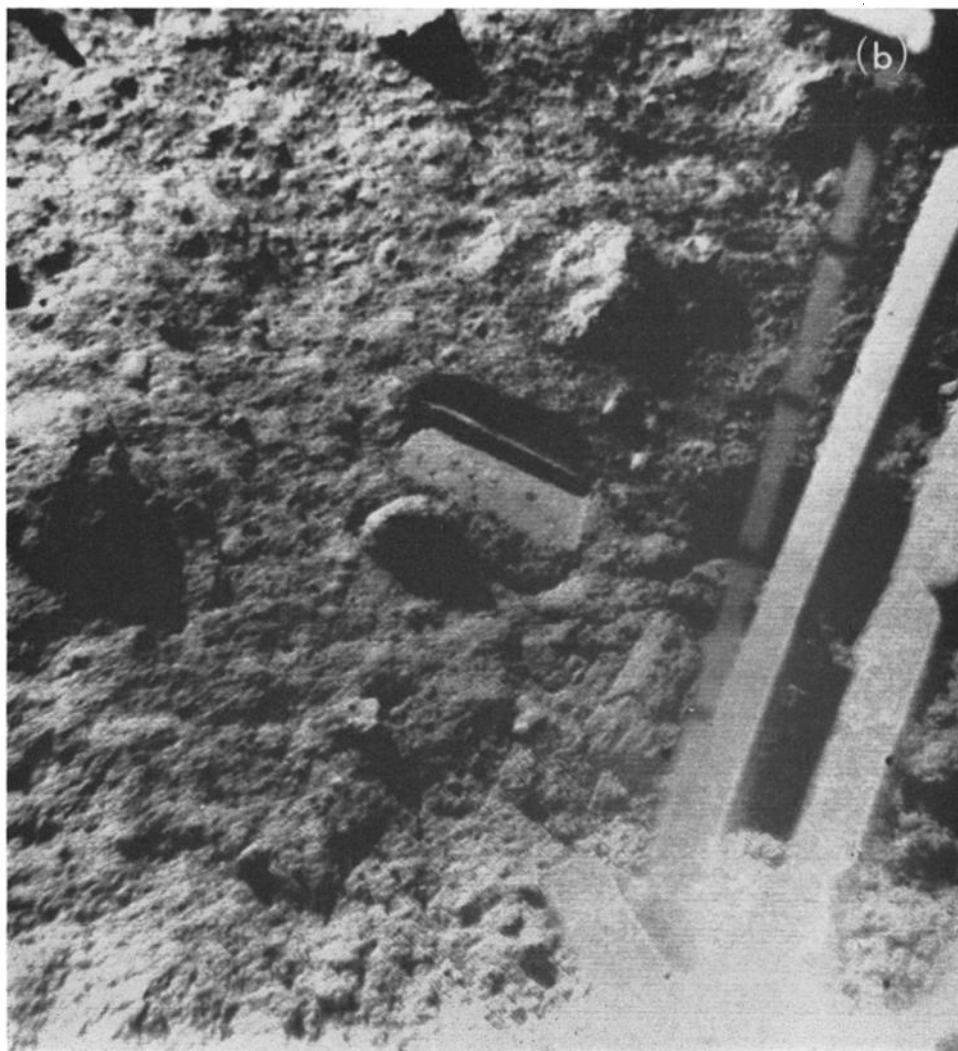
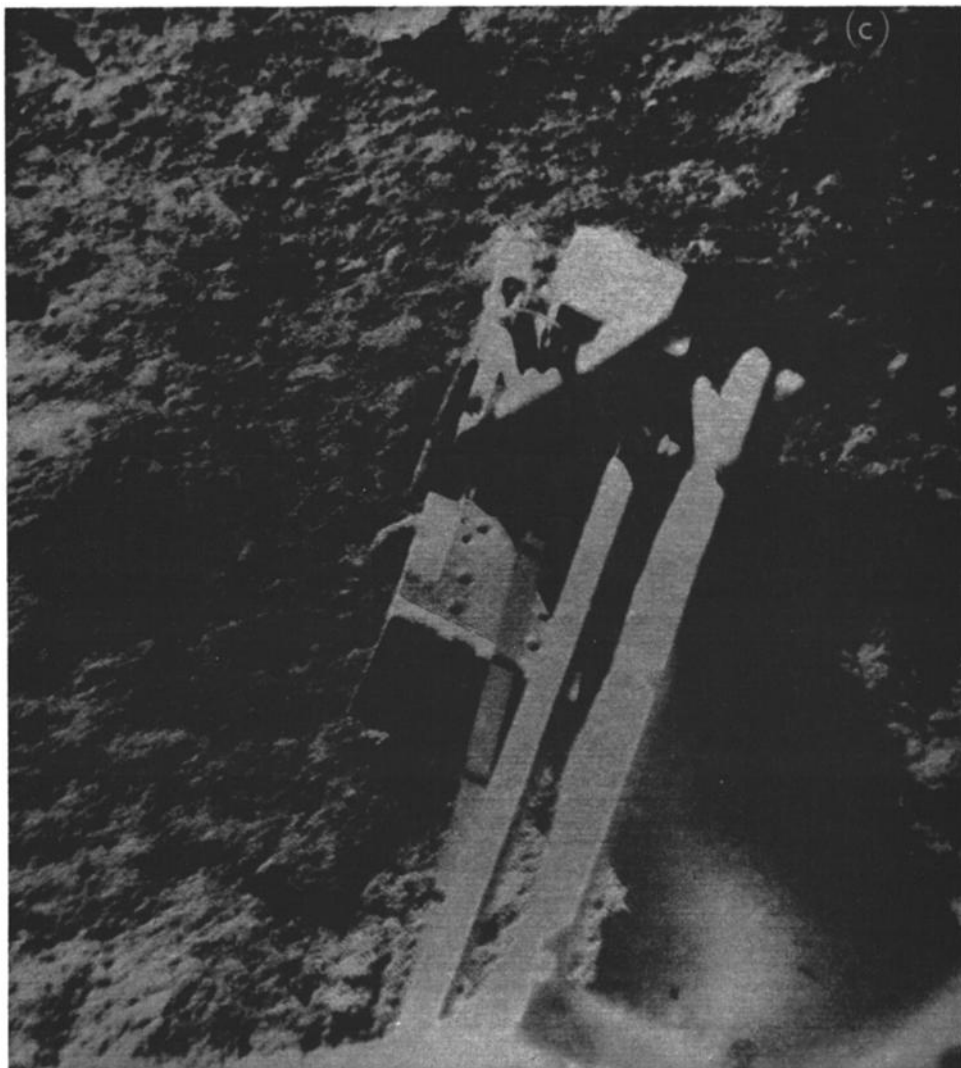
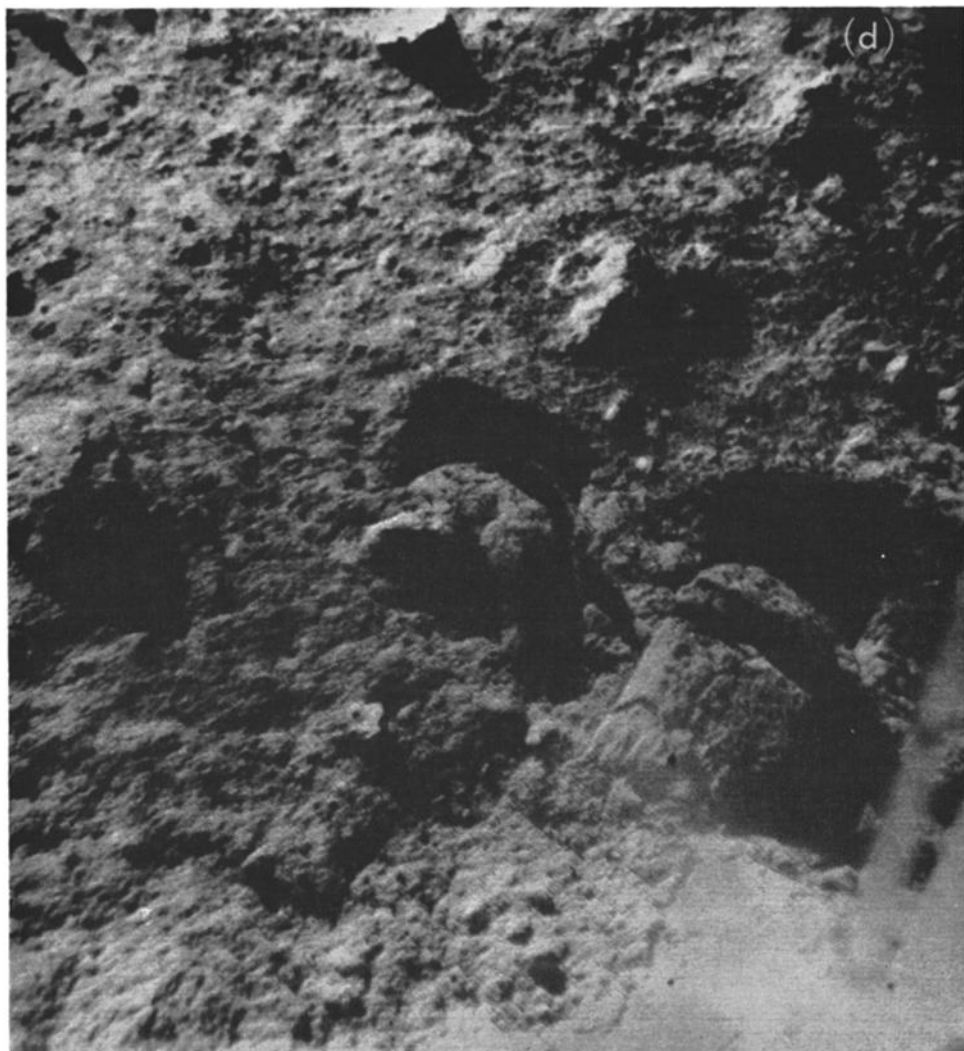
Fig. 19a. Bearing tests 8 and 9 in sequence.

Fig. 19b. Bearing tests 8 and 9 in sequence.

Fig. 19c. Bearing tests 8 and 9 in sequence.

Fig. 19d. Bearing tests 8 and 9 in sequence.

Bearing test 9 was performed at the same location, after opening the scoop door. The test, shown in Figure 19c and 19d, consisted of two 2.0-second lower commands. After the scoop

were being obtained from test to test during Surveyor 7 surface-sampler operations, two special tests were performed to study this effect (see Figure 19). Figure 19a shows bearing test 8, which resulted in an extremely small amount of penetration into the surface. In this test, the far edge of the surface-sampler scoop penetrated perhaps 1 cm, whereas the near edge of the scoop penetrated approximately 0.5 cm, and extremely little surface disturbance was manifested on the near side of the scoop. The impression left by the surface sampler is smooth and distinct (Figure 19b), and the various features of the scoop tip can be seen clearly. Because of the possibility that in this test the
